Final Work Plan for Groundwater Baseline Investigation at U.S. Navy's Eastern Maneuver Area Vieques Island, Puerto Rico

Department of the Navy
Atlantic Division
Naval Facilities Engineering Command

**Work Plan for
Groundwater Baseline Investigation at
U.S. Navy's Eastern Maneuver Area,
Vieques Island, Puerto Rico**

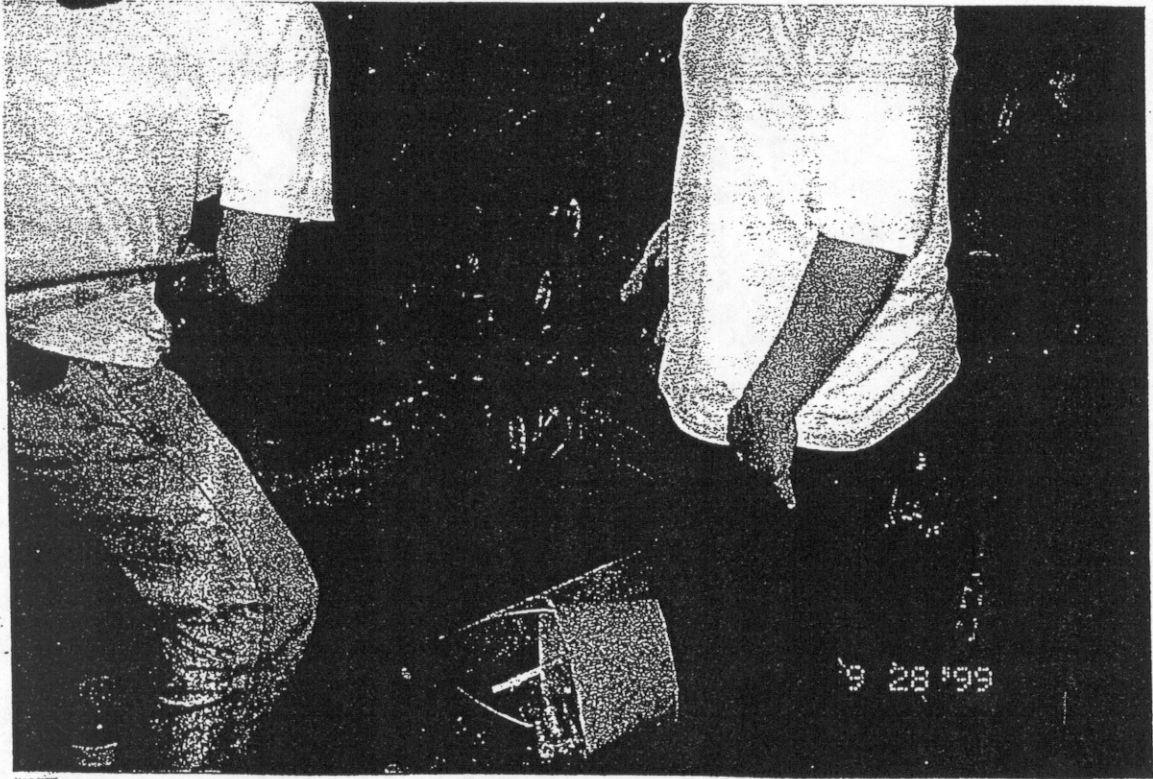
Photo # 5: [REDACTED] well (located on the north side of the Vieques), is not readily accessible.
